Specialized Loss Adjusting Division  
James E. Podesva, RPA  
Executive General Adjuster

## Memorandum

Re: Wynn Resorts  
Water Damage Loss  
7th Floor Apartment  
817 5<sup>th</sup> Avenue, New York, NY

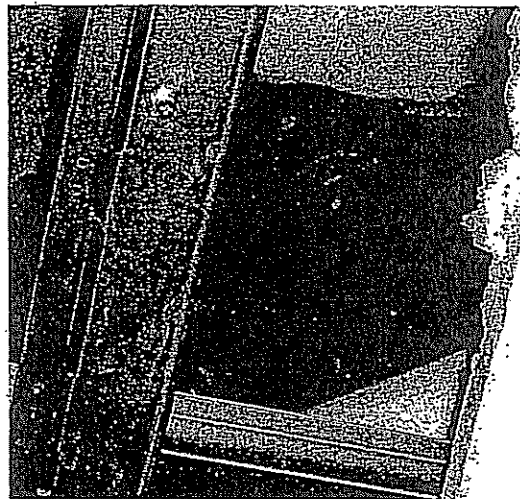
The loss was caused by a water pipe break that we believe occurred within a wall cavity of the 8<sup>th</sup> floor apartment. The reason for the water pipe break is unknown, because the leaking section has not been located.

WATER PIPE IN 7<sup>TH</sup> FLOOR CEILING GOING TO 8<sup>TH</sup> FLOOR APARTMENT

I spoke with the building handyman, Harold (last name unknown), who told me the plans to locate and repair the leaking pipe. The owner of the 8<sup>th</sup> floor apartment has hired an architect who is coming on Monday January 3, 2005 to locate source. The building handyman has contacted a plumber who will be standing by to make the repairs once the pipe is located. The nature of the break is not known, and Harold agreed to remove the leaking pipe (or valve) and set it aside for examination later.

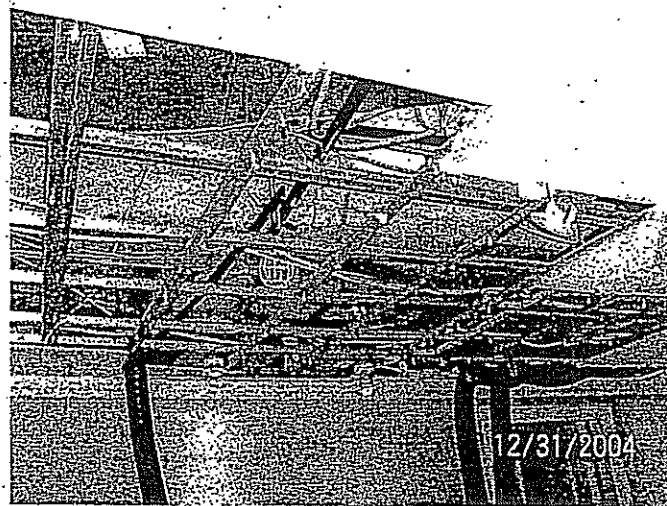
This room has the most serious damage.

MAIN HALLWAY CEILING WITH DRYWALL REMOVED

Replace all of the sheetrock ceiling and insulation. The two-piece crown molding will need to be removed to accomplish this.

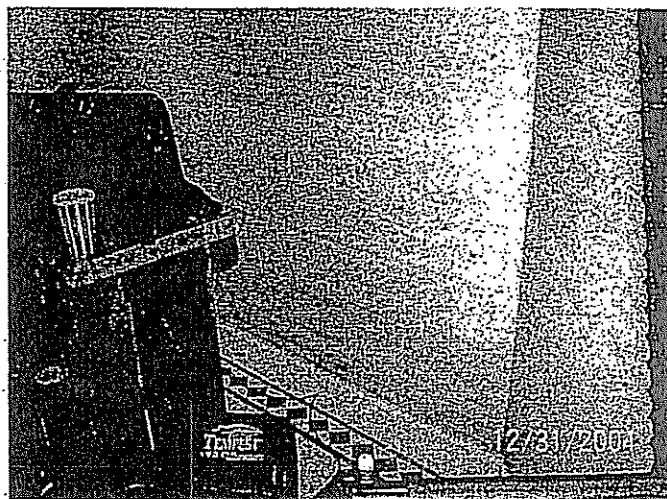
The walls are covered with a padded fabric that was wet and is wrinkling near the baseboard molding. The designer and the contractor who installed the fabric say that it cannot be removed, or stretched in place without causing more damage to the fabric. If the fabric must be repaired, and I believed that it will, then all of the material in the hallway will have to come out. I am told by Tishman construction, that this is an imported German material that is no longer available.

MAIN HALLWAY WALLS WITH FABRIC IN PLACE

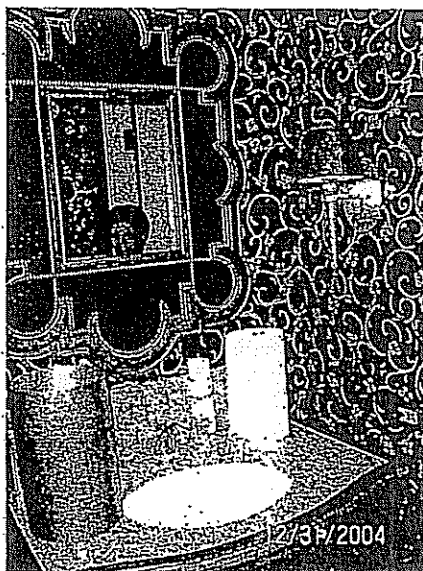
This room was located next to the small closet where most of the water entered the apartment. The wall fabric was still wet when I examined it, and the ceiling and insulation were still in place but obviously damaged to the point that it had to be replaced. Your consultant from Hillman Environmental recommended that the ceiling and the fabric walls be removed to allow for the property drying of this room.

POWDER ROOM WALL FABRIC IN THE AREA WHERE THE WATER ENTERED THE ROOM

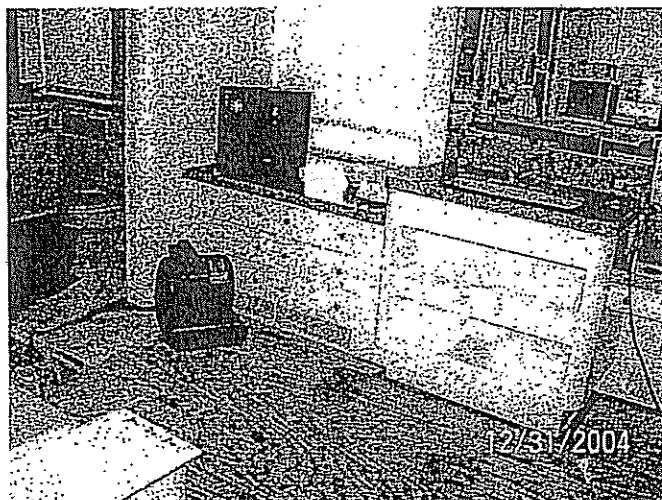
Only the carpeting in these rooms was damaged, and it had already been removed and thrown out by the time I arrived.

BATH ROOM WITH CARPETING REMOVED

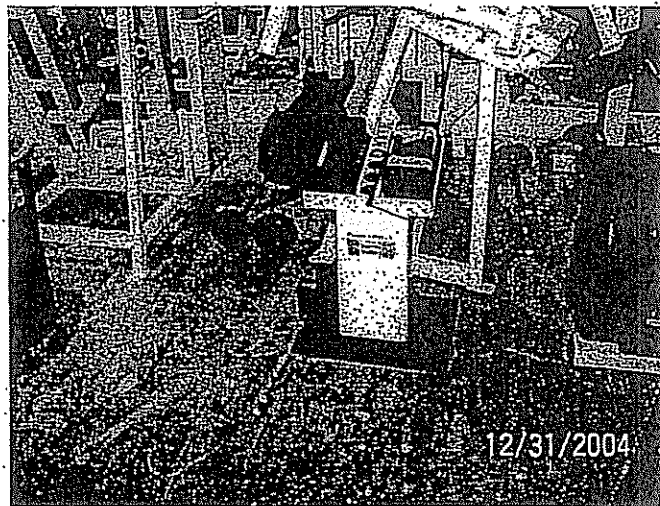
EXERCISE ROOM WITH CARPETING REMOVED

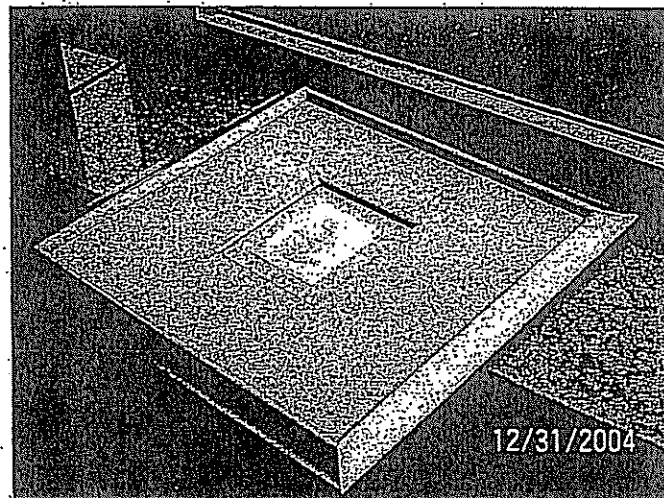
There was very little content damaged by the loss. The housekeeper showed my two paintings that had come in contact with water. The damage appears minor to me. The actual painting was not damaged, but the mat and the back of the frame was. I believe that these items can be re-

SMALL RELIEF ETCHING WITH STAIN ON LEFT SIDE OF MAT

framed. I do not think an art conservation expert is needed to evaluate the condition of these two paintings.

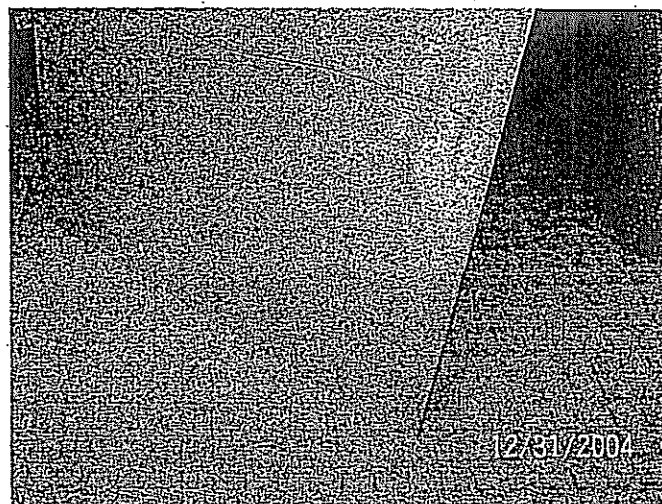
LARGER PRINT WITH WATER STAIN ON THE BACK
